Memorandum

Date:	June 7, 2007
То:	Chris Dreps Upper Neuse River Basin Association
From:	Sally Hoyt and Anne Kitchell Center for Watershed Protection
Re:	Lick Creek Fieldwork – Findings and Recommendations

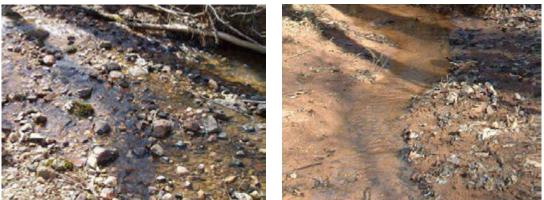
RCH-218 (left) shows the rocky substrate dominant in the eastern part of the watershed. RCH-402 (right) shows bed material in a relatively un-impacted Triassic Basin stream.

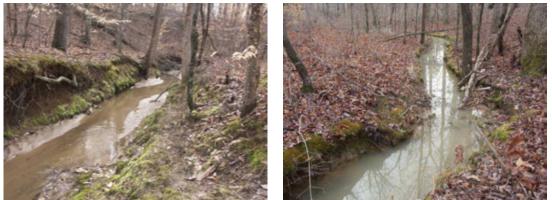
Historic impacts resulting in channelization in RCH-302 (left) and RCH-301 (right).

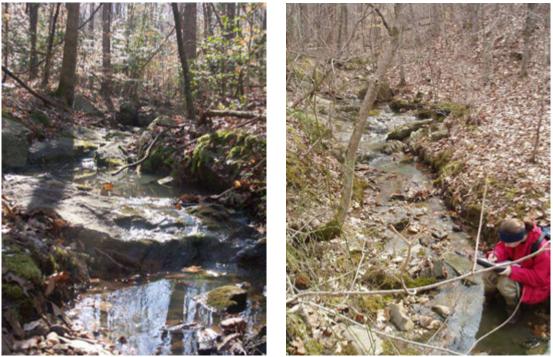
RCH-506 (left) and RCH-206 (right) Optimal reaches in Laurel Creek.

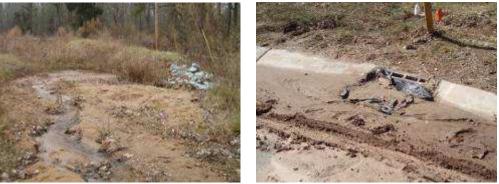
MI-205 (left) Filled sediment basin lacks functional storage. Near IB-110 (right) Un-maintained inlet protection.

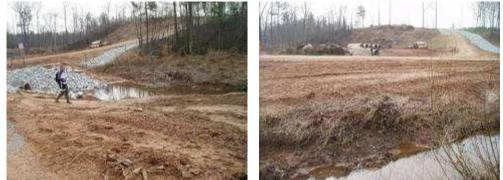
- Kingsmill Dairy. Active construction including roads, culverts, and buffer clearing was observed at the Kingsmill Dairy site. No erosion and sediment controls were present and all riparian vegetation was removed in some stretches (IB-210). Significant sediment deposition was observed downstream of this site, a finding that correlates with the downstream turbidity readings that are consistently the highest among City of Durham monitoring sites. Downstream neighbors complain of the sediment influx and the higher storm flow discharges. This bovine R&D facility has also constructed several buildings in recent years, indicating that the lack of erosion controls may be a long-term impact.

IB-210 Cleared buffer and road construction lacking S&E controls at Kingsmill Dairy.

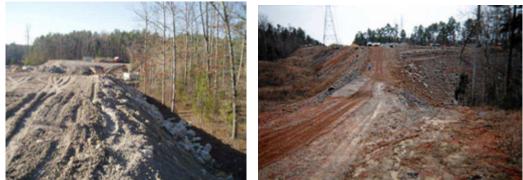
MI-201 (left) Concrete block maker. SC-209 (right) Dirt and debris receiving site.

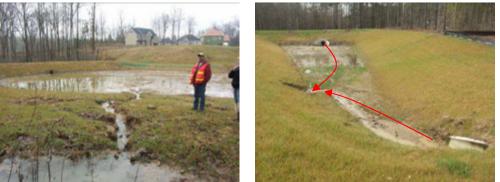
MI-301 (left) This approved in-stream pond at Brightleaf destroyed a natural stream and buffer. MI-303 (right) This pond in Brightleaf demonstrates the typical unimaginative site layout and short flow path. MI-303 is recommended for a retrofit to lengthen the flow path.

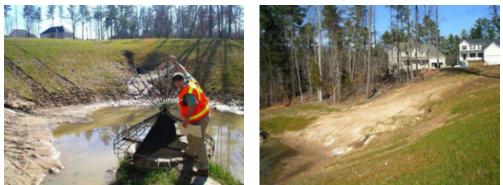
One of the 40 one-year detention ponds in Brightleaf. The small volume and short flow path (left) will make water quality retrofits difficult. The steep slopes (right) impede maintenance access.

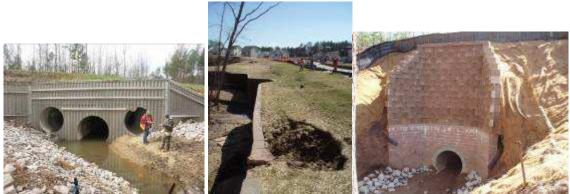
SC-301 Golden Parkway (misaligned culvert); SC-111 poor drainage design behind headwall of interlocking concrete block; SC-112 poor headwall design.

• Follow-up with structural repairs to headwalls. Refer to Appendix A, *Table A-2: Enforcement* for a list of the sites at active construction sites that need repair.

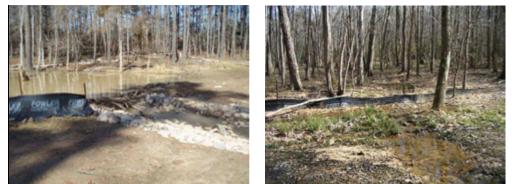
UT-111 (left) sewer cuts wetland in half. UT-305 (right) the Brightleaf pump station at Brightwood Trails is adjacent to the wetlands and likely in the wetlands.

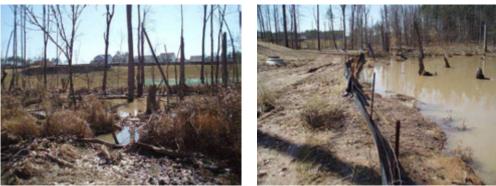
IB-110 impacted wetlands directly and indirectly. Not the fill slopes in or adjacent to the wetland off Woodsdale Court (left) and the proximity of the sewer to the wetland near Alyea Court (right).

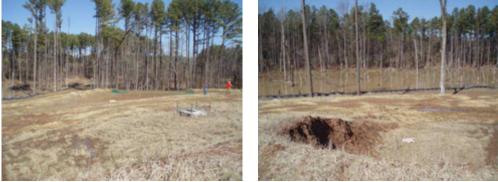
IB-110 the wetland hydrology is impacted by the bisecting sewer (left) and by the lack of buffer (right) near Alyea Court.

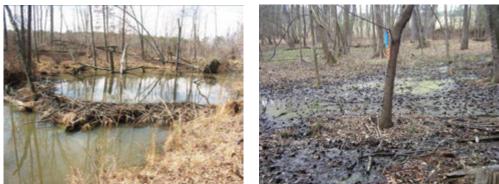
RCH-304 (left) These beaver dam impoundments and associated wetlands are not shown on the NWI. The valley is also not shown to have a floodplain. RCH-331 (right) is an example of wetland area where the flagged boundary was not discernable.

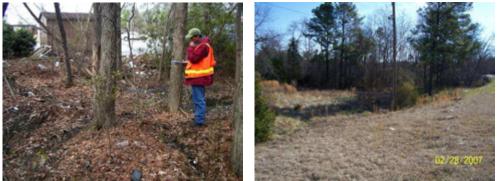
R-300 (left) Proposed wetland downstream of Pizza Hut and Burger King in degraded natural area remnant. R-301 (right) Proposed wetland area downstream of Route 70 outfall.

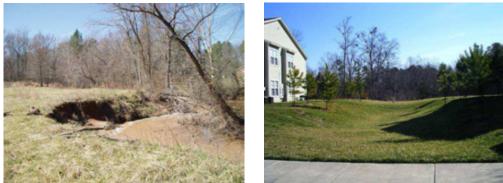
RCH-340 (left) Olive Branch stream restoration site with potential to incorporate floodplain wetlands. R-302 (right) Proposed dry swale at Triangle Pointe Apartments.

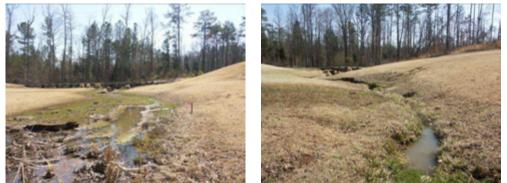
RCH-521 (left) and RCH-517 (right) Two of several potential buffer plantings at Falls Village Golf Course.

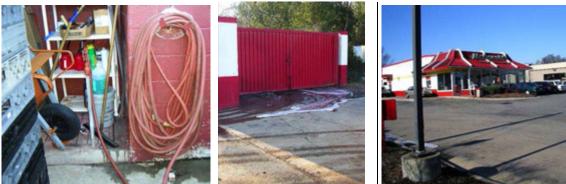
H-300 McDonald's at Route 70 and Mineral Springs Road. Dumpster area is set up for washing (left). Wash-water leaves the dumpster area (middle) and flows though parking lot to storm drain inlet near parking lot entrance from Route 70 (right).

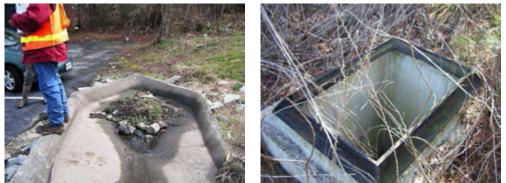
Repair projects include storm drain infrastructure such as this inlet at Pizza Hut (MI-306) (left) and stormwater management ponds (MI-320) (right).

• Forward list of repair sites to DOT or other appropriate public works agency
