# Memorandum

**To:** Chris Dreps  
Upper Neuse River Basin Association

**From:** Sally Hoyt  
Center for Watershed Protection

**Re:** Summary of Field Work Activities in Little Lick  
Creek – January 2005

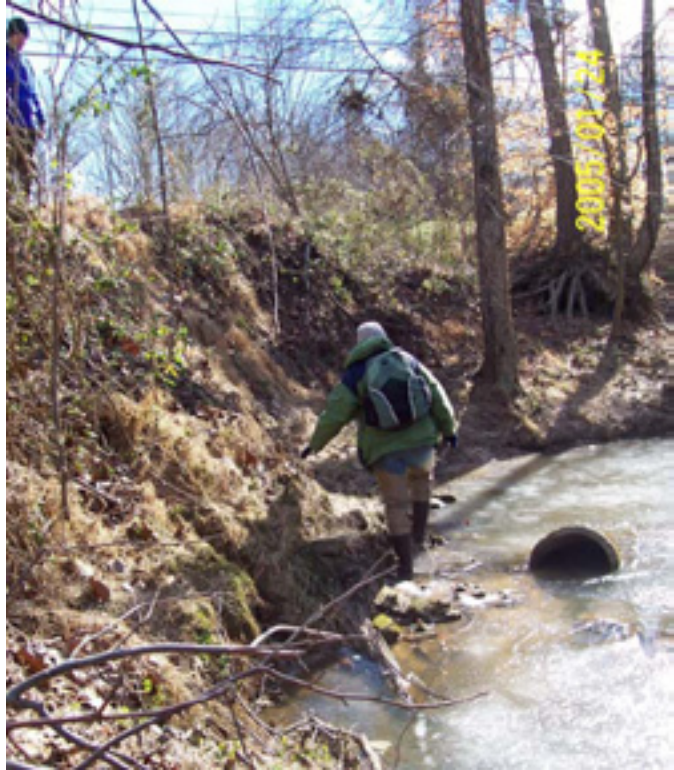
RCH2-1 Example of deeply incised, but currently stable stream bank

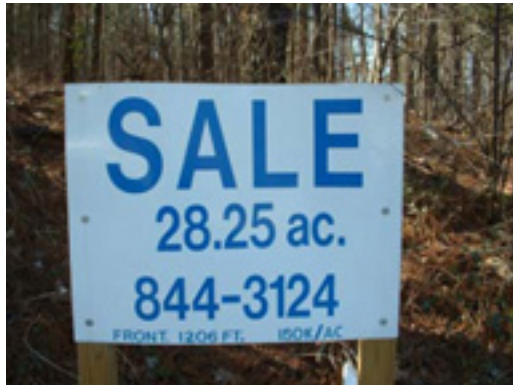
RCH2-9 Development is coming

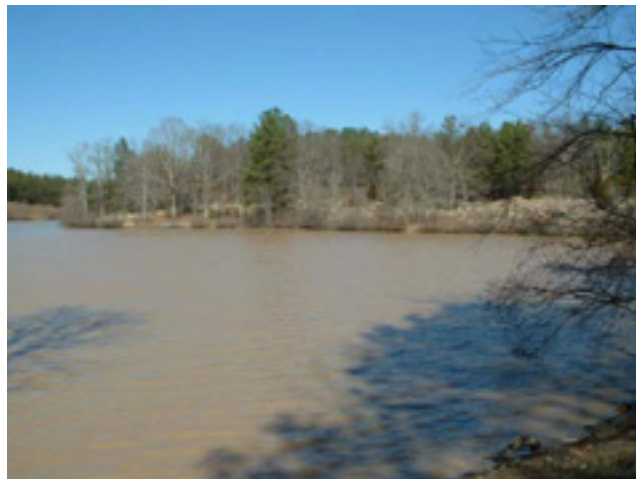
- Cardinal Lake – a large, existing lake – found to be sediment laden due to active construction adjacent to the lake. Either sediment controls for the ongoing development were failing/inadequate or the lake was being used as a sediment basin. Excavated material was being stockpiled adjacent to the lake. This violates the Durham County standards regarding required effective buffer zones (Sec. 14-56 (1)a) and possibly the prohibition of the use of existing lakes as sediment basins (Sec. 14-65 (j)(3)).

RCH8-14 Cardinal Lake – Sediment laden; stockpiling adjacent to shore

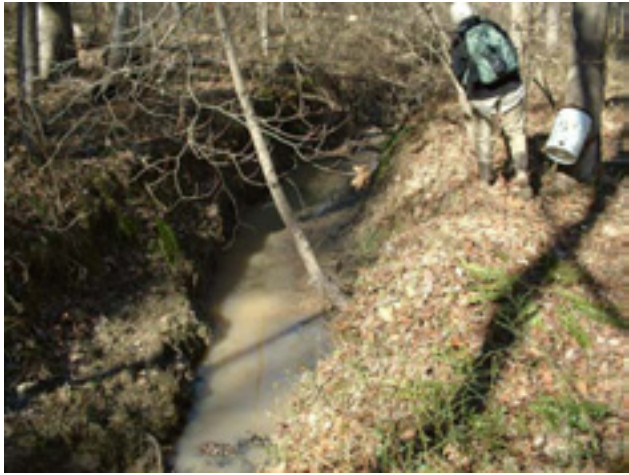
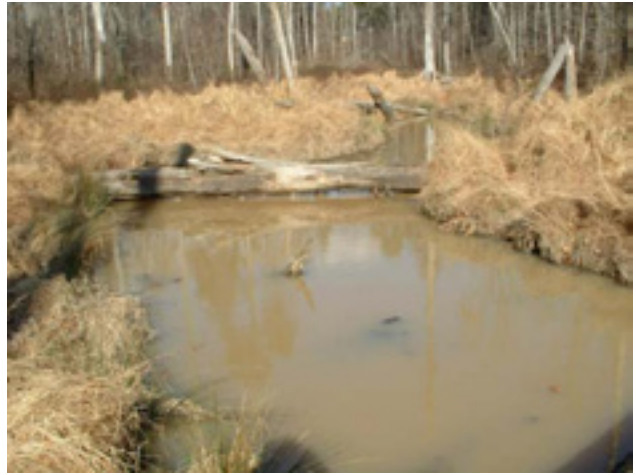
RCH8-14 (left photo) and RCH8-12 (right photo) Sediment laden stream, downstream of Cardinal Lake

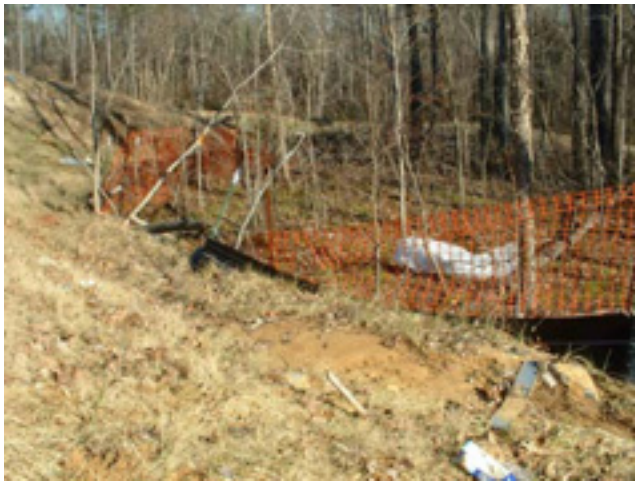
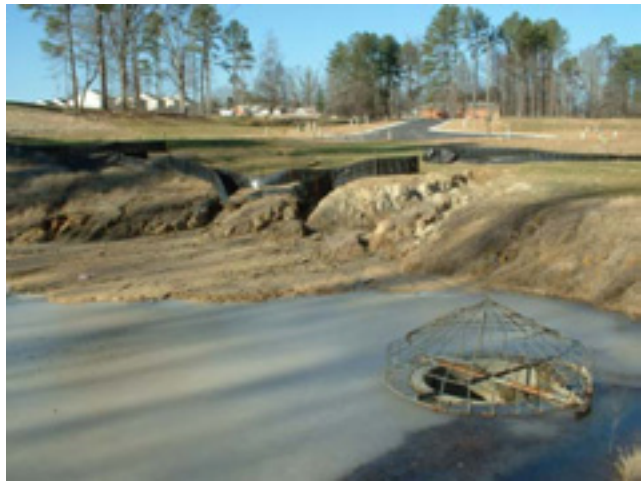
- Failure to maintain erosion and sediment controls. For example, silt fences that were overtopped by sediment or undermined by erosion were noted. These devices should be inspected following storms greater than 0.5 inches to ensure that they are intact and functioning properly. Local ESC regulations/criteria should be explicit about maintenance and inspection requirements such as this.

RCH2-12 Unmaintained erosion and sediment controls (left photo). Upstream area was graded and seeded, but has not yet stabilized. The sediment load carried down this hill overwhelmed the silt fence and is filling in the sediment basin (right photo).

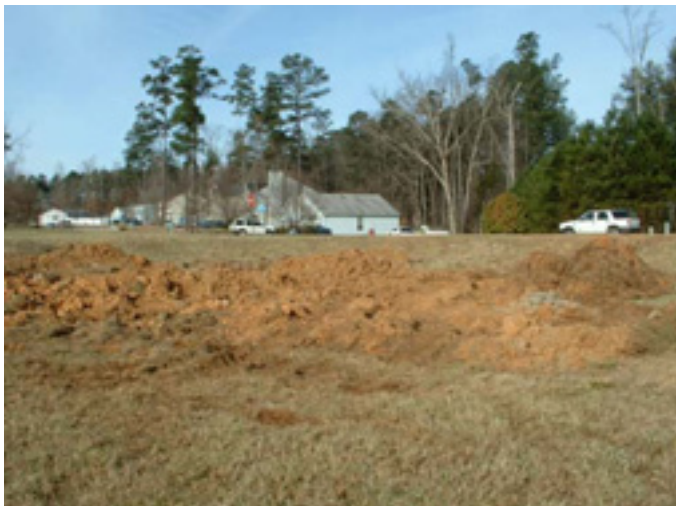
RCH13-1 No ESC provided for on lot construction (Photographer standing adjacent to stream channel)

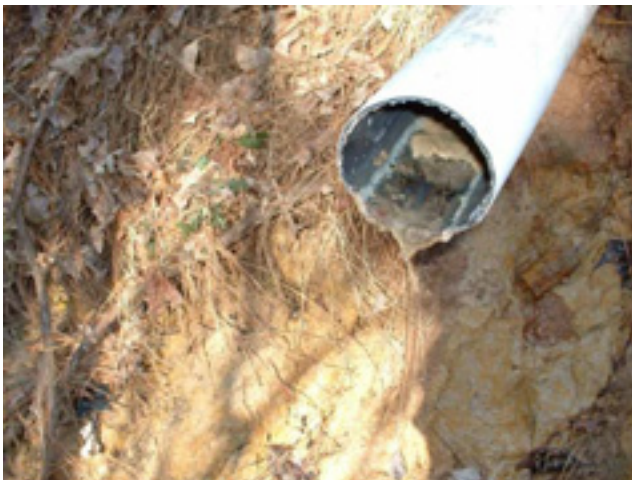
**Sand filters (on-site septic systems)** contribute to contaminant load when improperly maintained, such as failure to replace chlorination tablets. Many of these failing systems are located in close proximity to sanitary sewers, meaning that the households could be connected to the municipal treatment system, which would provide more reliable wastewater treatment.

RCH2-10 Outfall of Failing Sand Filter

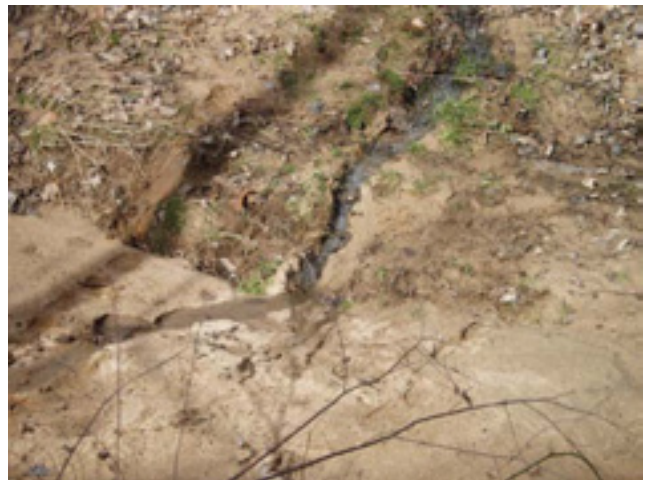
RCH3-2 Sanitary sewer leak: (UT3-1)

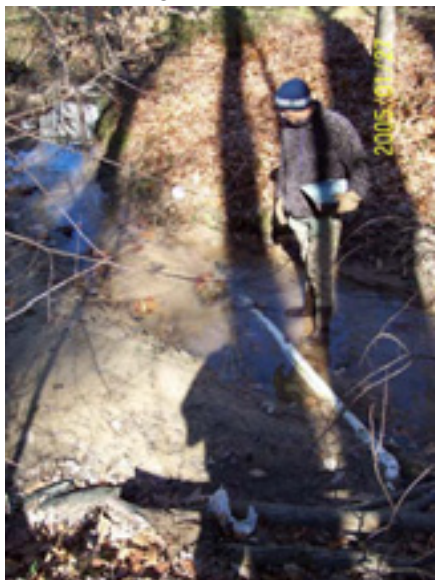
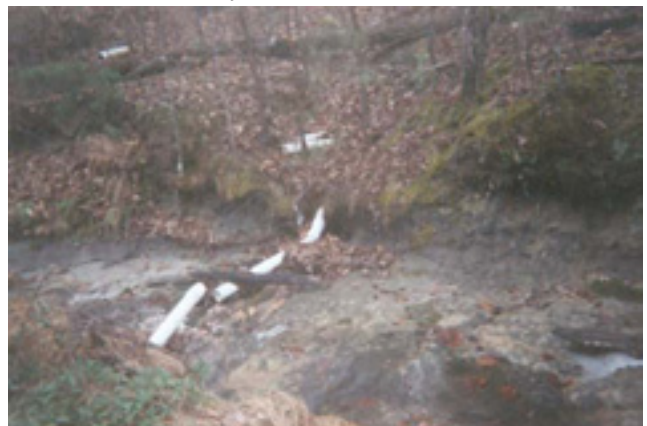
**Sanitary sewer laterals** (house connections) laying above stream inverts so that the pipe is exposed in the stream channel. These laterals were often PVC or another material joined to PVC and failed as a result of improper pipe connections and fittings or from being smashed by debris and bedload carried by the stream.

RCH5-8 PVC sanitary sewer laterals in stream (above and left)

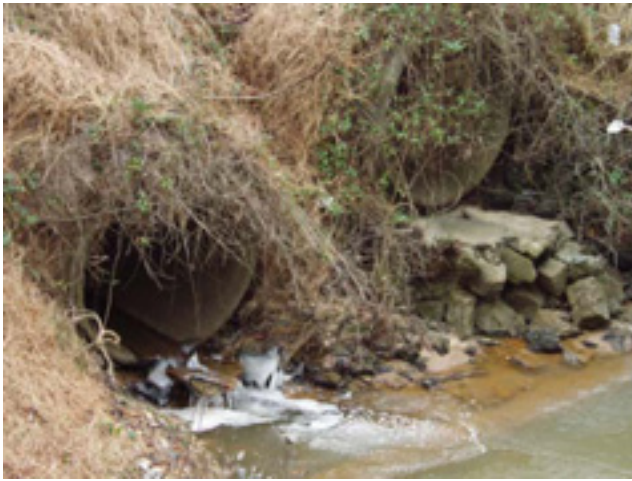
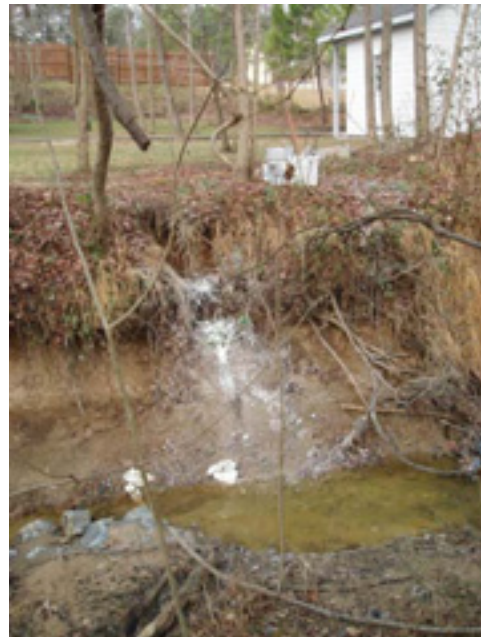
RCH3-4 Illicit discharge – wash water (left)  
RCH3-7 Illicit discharge - Paint dumped in stream (right)

Other observed illicit discharges included wash water, cooking oil, and paint dumping. These sites require enforcement and education.

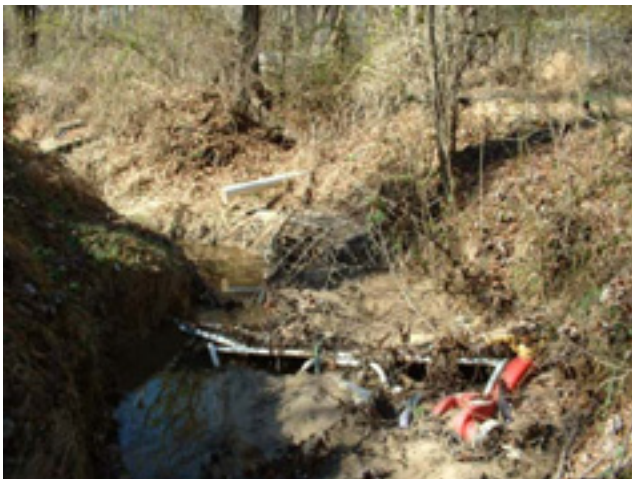
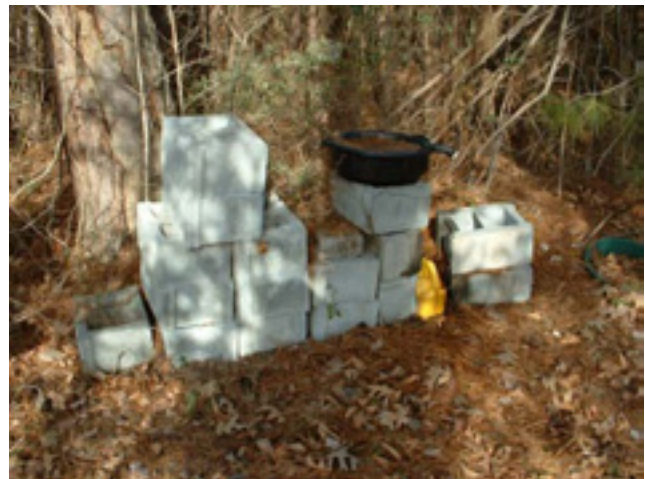
RCH2-10 Residential trash behind homes on Jones Circle (left). RCH13-1 Oil changing supplies stored 10' from stream (right)

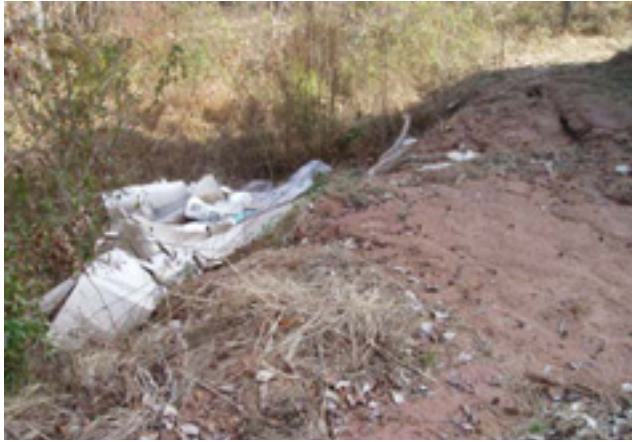
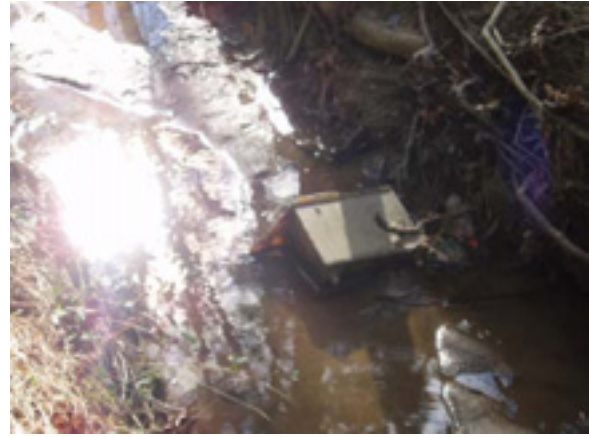
RCH6-7 Construction Debris and lack of sediment control (left). RCH3-4 Battery in Stream (right).

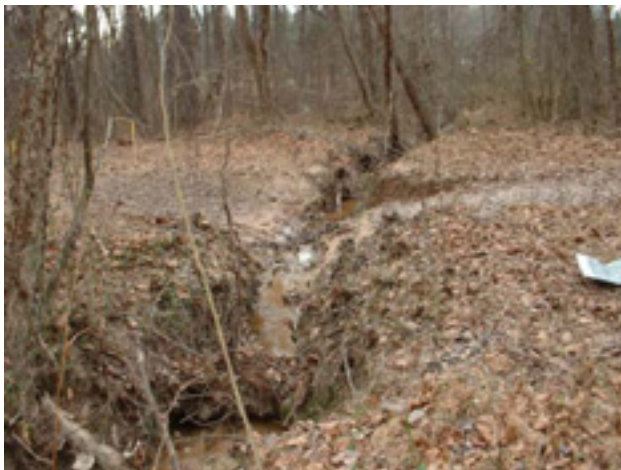
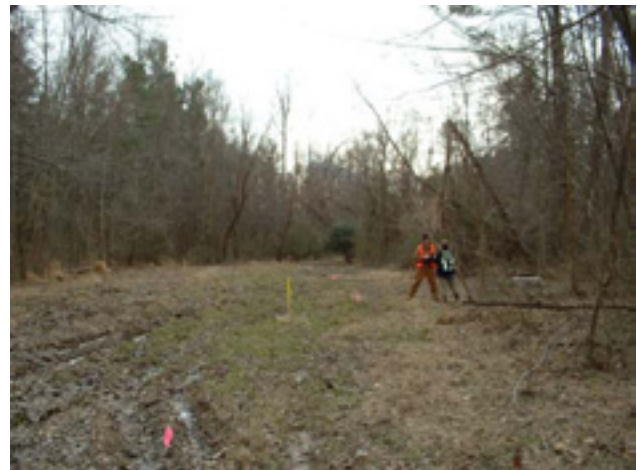
RCH2-3 Example impacts of sewer ROW

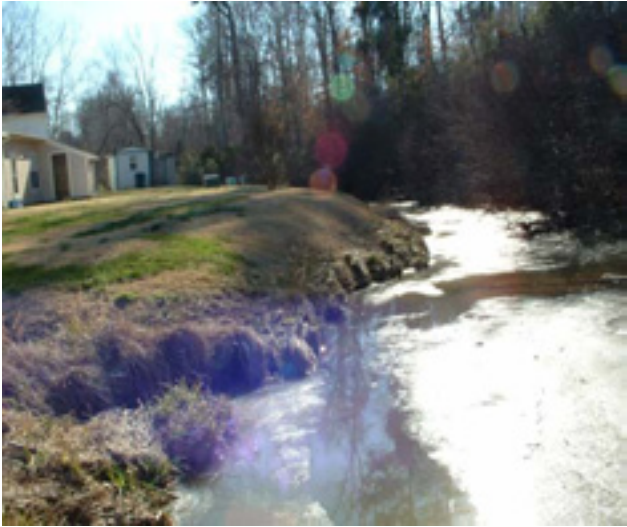
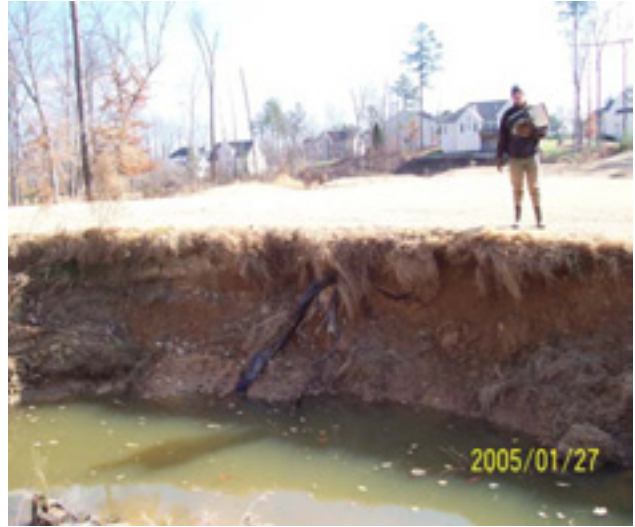
RCH2-11 Homeowners mowing to edge of stream (left). RCH5-10 Bank erosion at golf course accelerated by lack of buffer.(right)

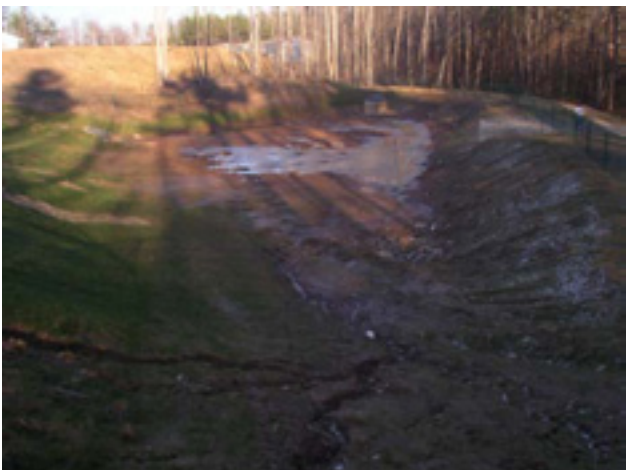
RCH1-13 Pendleton Apts SWM (left)

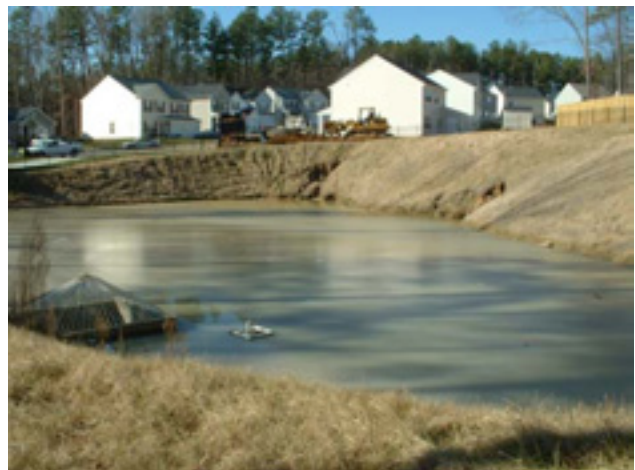
RCH2-12 Stormwater pond in use as sediment basin (right)

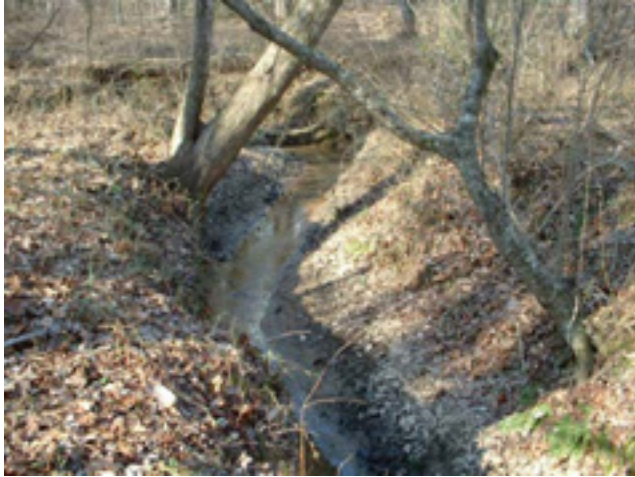
RCH8-13 Example of Excellent reach

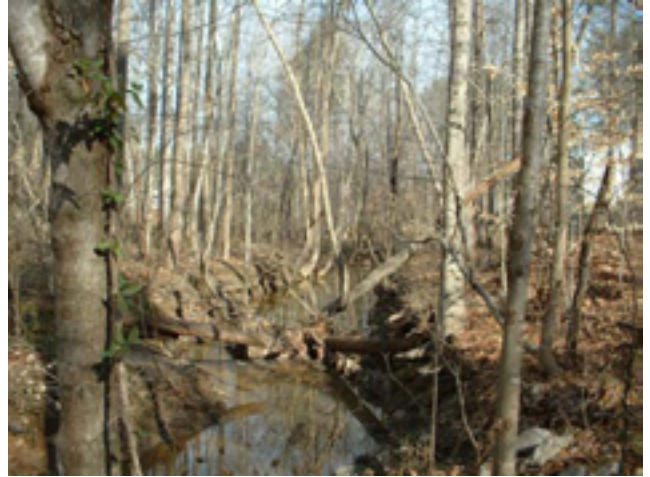
RCH2-13 Example of Good reach

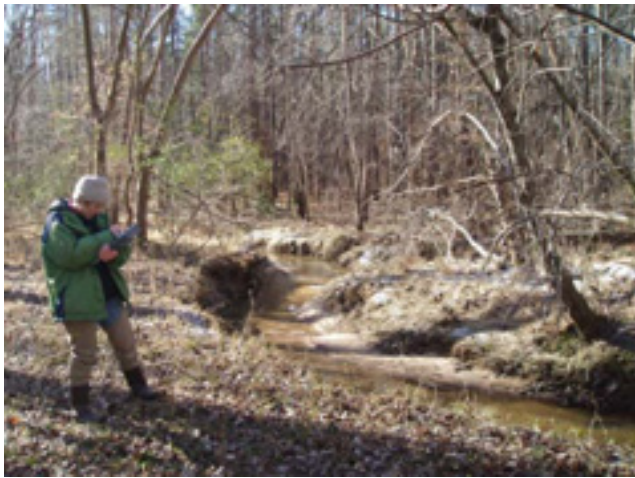
RCH10-2A Example of Good reach

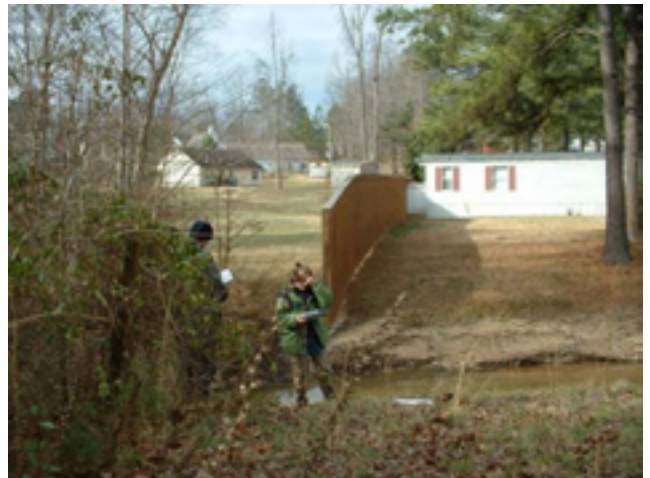
RCH2-13/14 Transition between Good/Poor reach

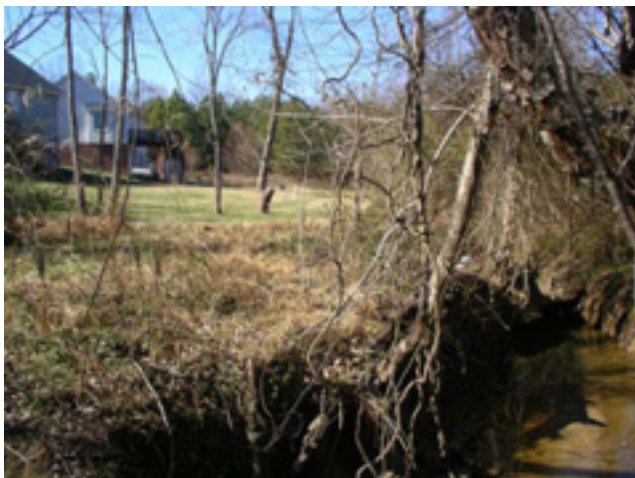
RCH4-6 Example of Fair reach

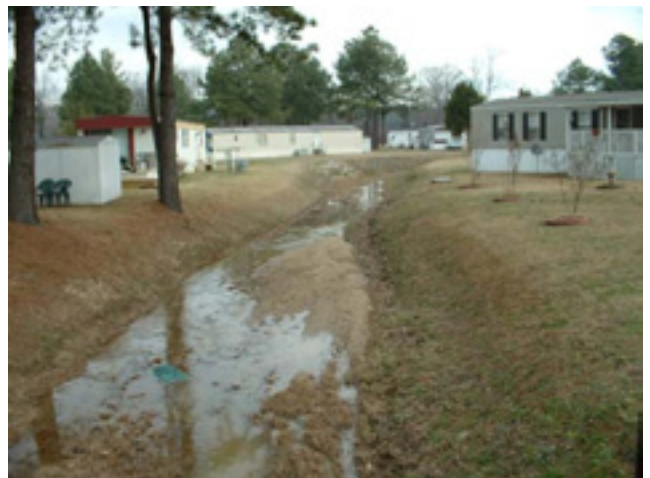
RCH2-14 Example Poor reach (Mainstem)
