# Upper Neuse River Basin Association

## Memorandum

To: Lick Creek Watershed Restoration Plan Partners and Stakeholders  
Cc: Kimberly Nimmer, NC Division of Water Quality  
From: Heather Saunders, Upper Neuse River Basin Association  
Date: July 23, 2009  
Re: Lick Creek Local Watershed Plan Demonstration Projects

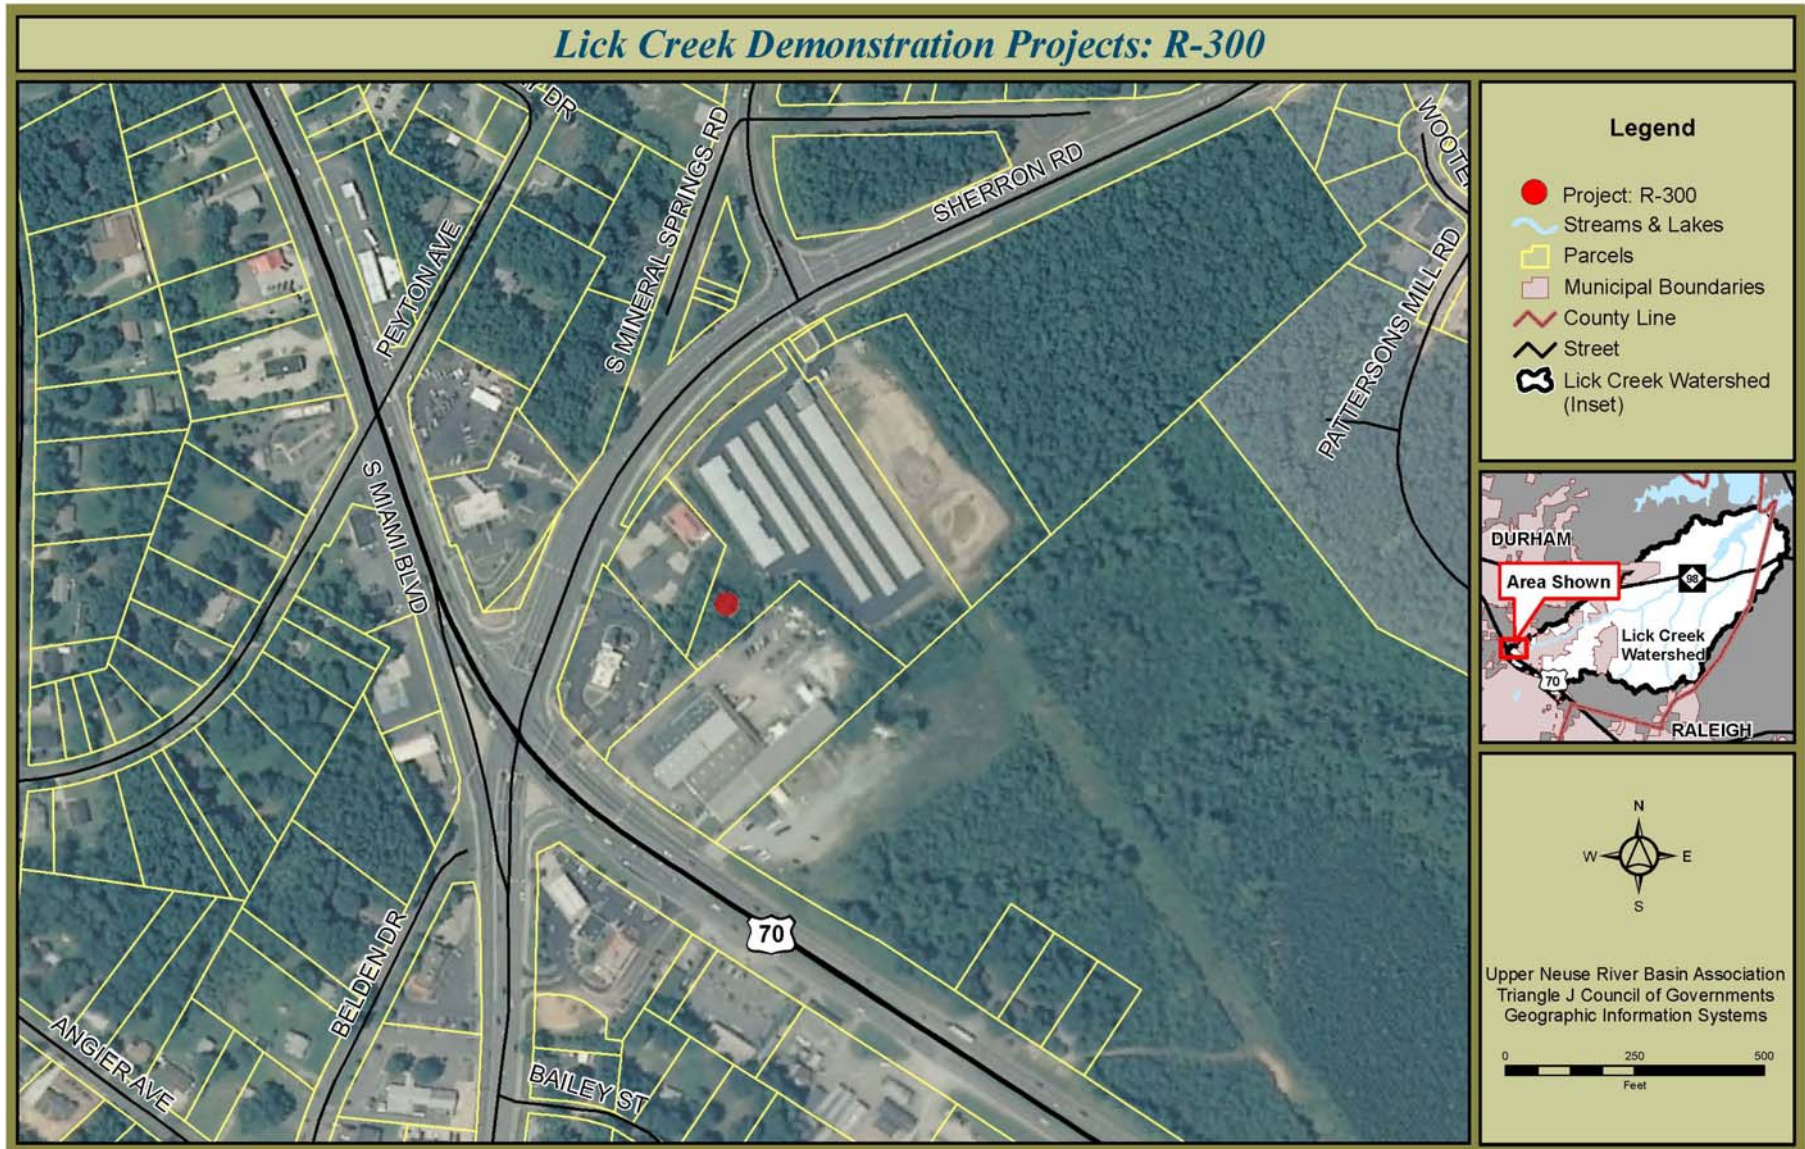
Figure 5. Lick Creek Demonstration Project R-300.

R-300 (proposed for a vegetated stormwater wetland) (Figure 5) would capture approximately 6.4 acres of stormwater runoff predominantly from roads, parking lots, and other impervious surfaces from one of the busiest intersections in Durham County. Approximately 84% (5.4 acres) of the drainage area is impervious cover, with only 15% (1 acre) being forested. Currently, the stormwater at this site is mostly bypassing a concrete conveyance built to accommodate storm flows, and is exiting to a poorly defined stream channel after passing through a low-lying area where commercial dumpsters are located.

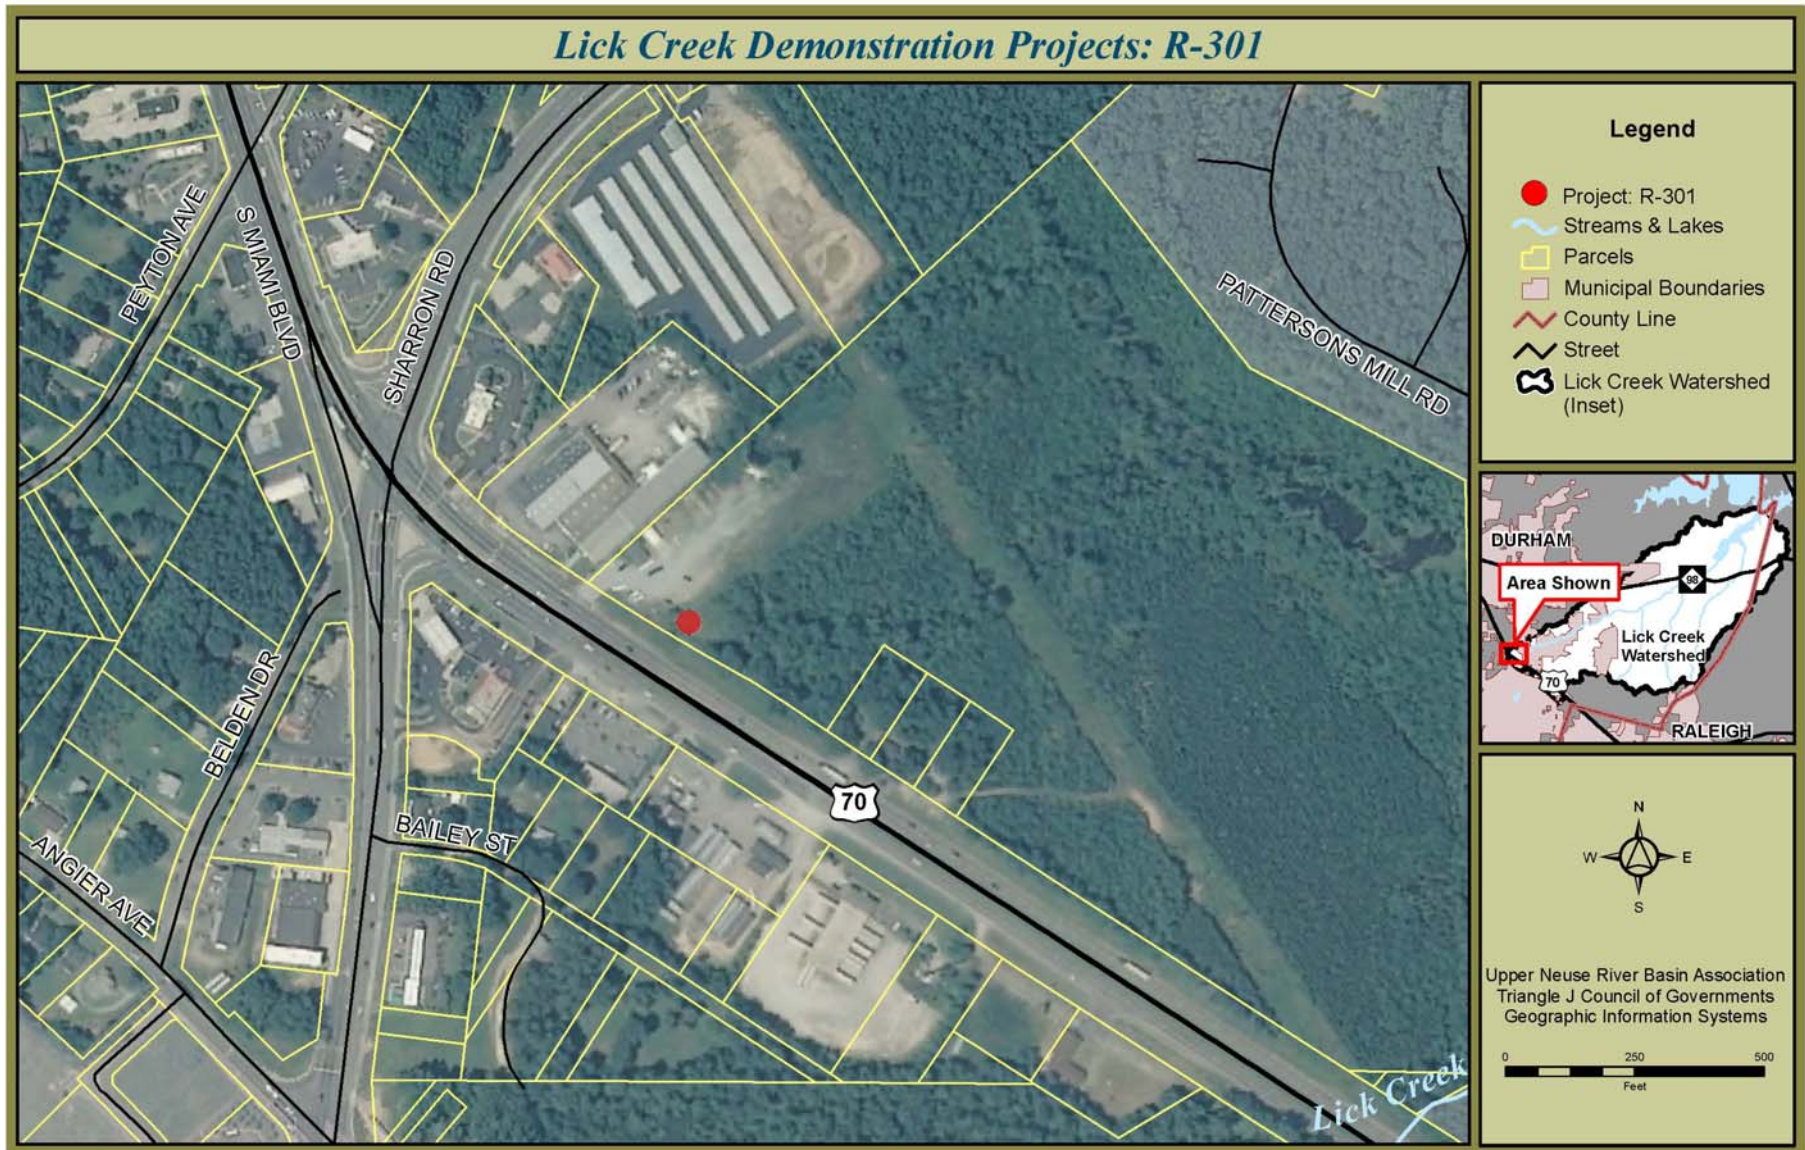
Figure 7. Lick Creek Demonstration Project R-301.

R-301 (proposed for a vegetated stormwater wetland) (Figure 7) would capture approximately 8.08 acres of stormwater runoff predominantly from roads, parking lots, and other impervious surfaces from one of the busiest intersections in Durham County. Approximately 90% (7.3 acres) of the drainage area is impervious cover, with only 10% (< 1 acre) being forested. Currently, the stormwater at this site is running directly off impervious surfaces. In addition, a 42-inch outfall pipe is directing stormflow directly into a pasture area sparsely vegetated, compacted scrub/shrub area.
