Little Lick Creek Watershed Plan

Technical Team Meeting 2 Thursday, March 17, 2005

Stream Assessment Findings

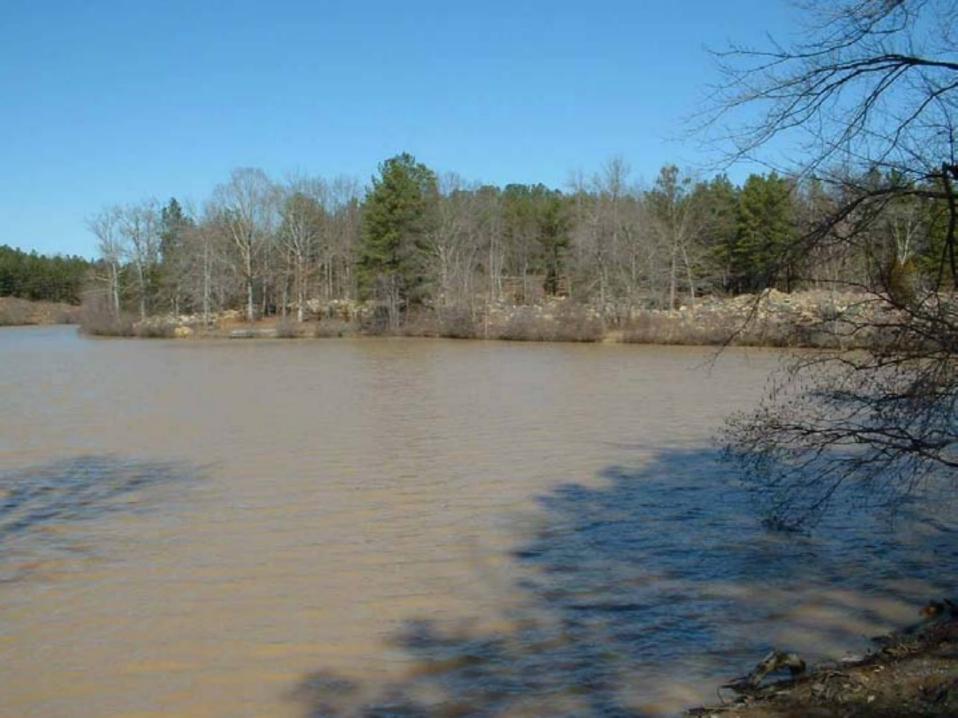
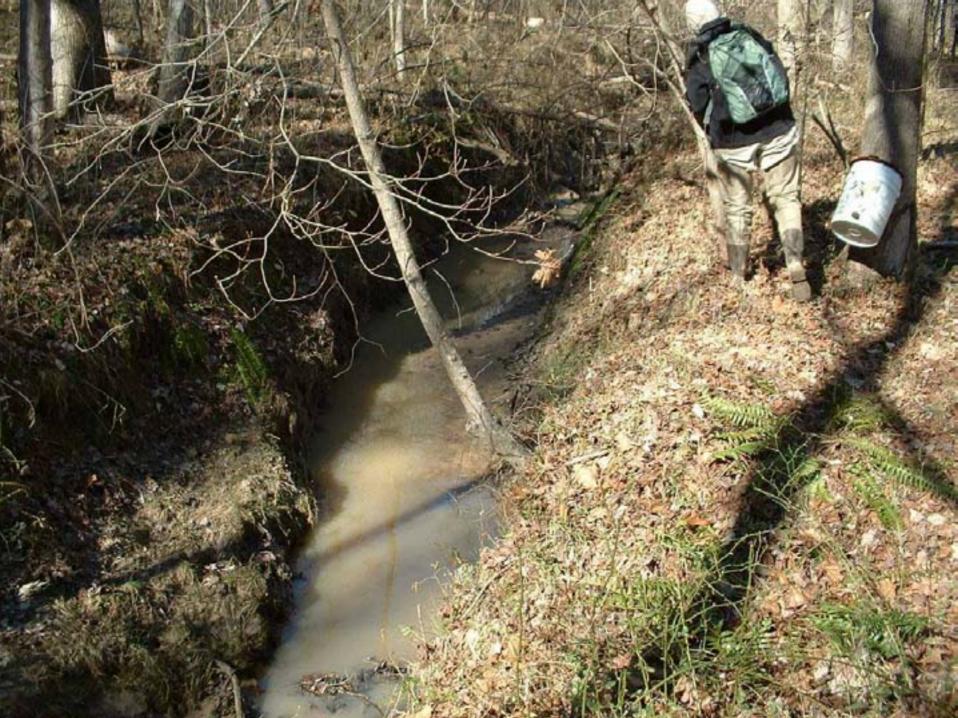
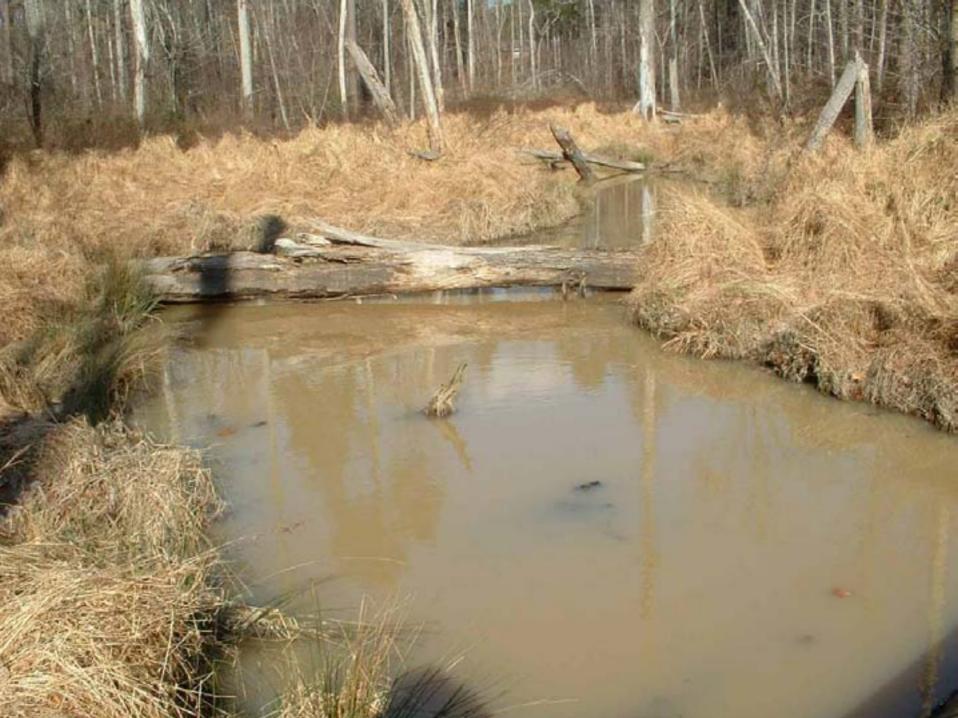
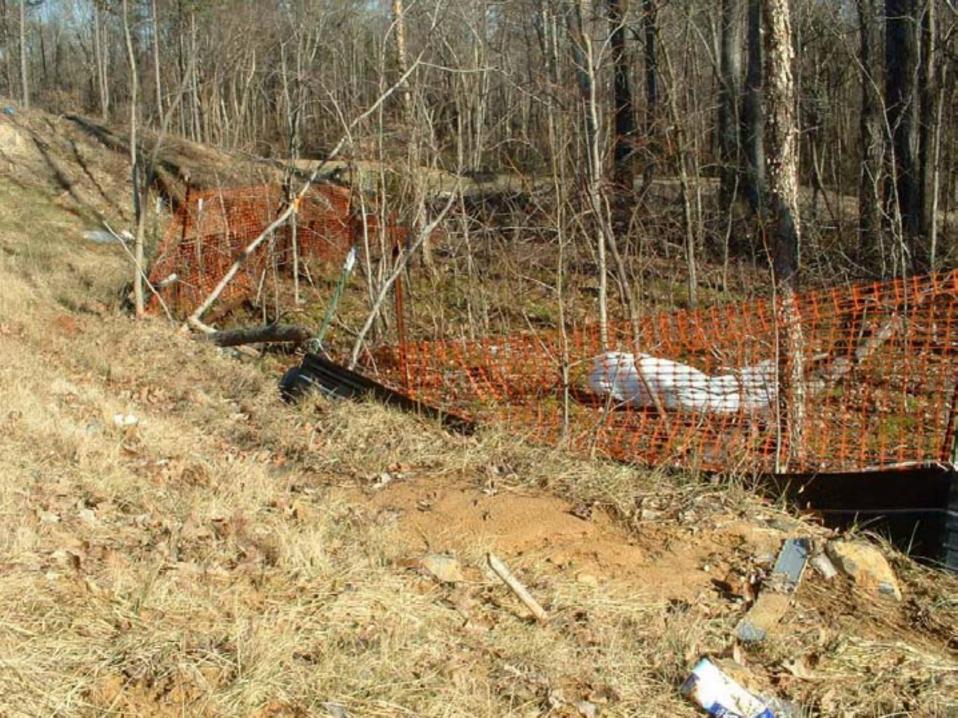
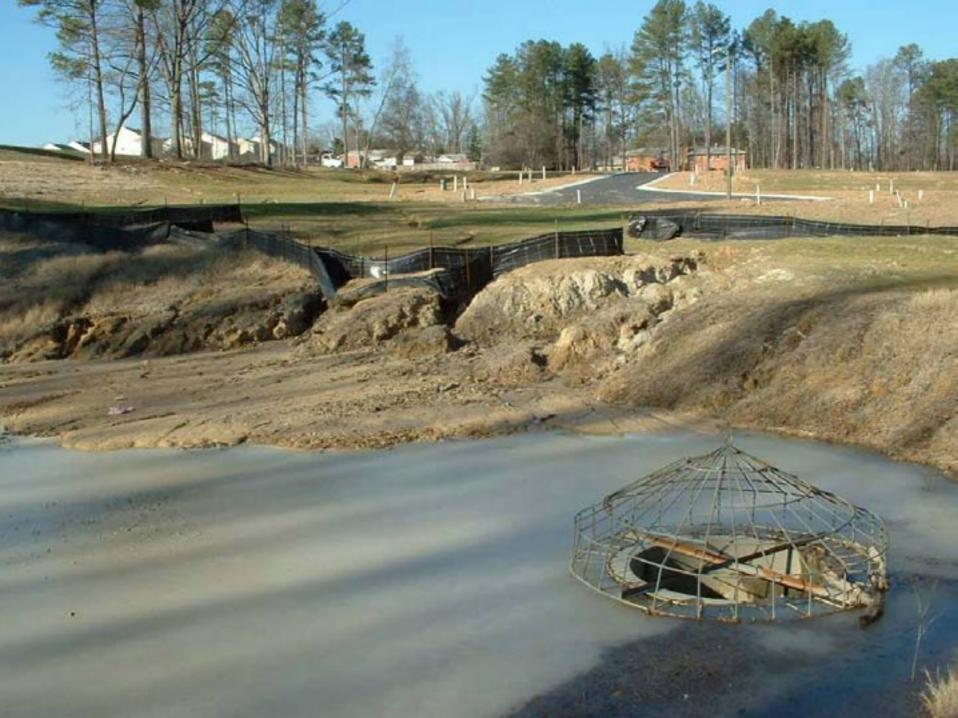
Erosion and Sediment Control

- Failure to maintain ESC devices
- Relying solely on sediment basin rather than combined approach

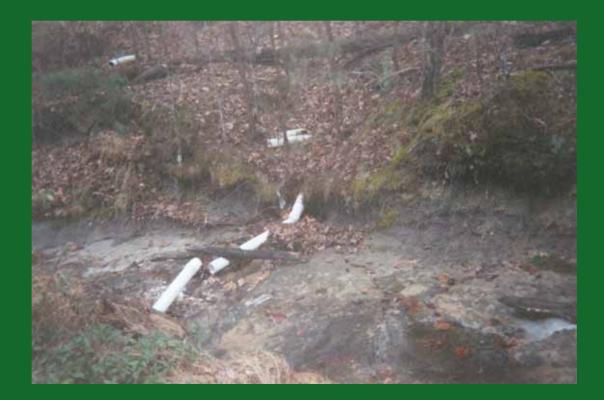
Sanitary Sewer Laterals

PVC laterals and cleanouts above stream inverts

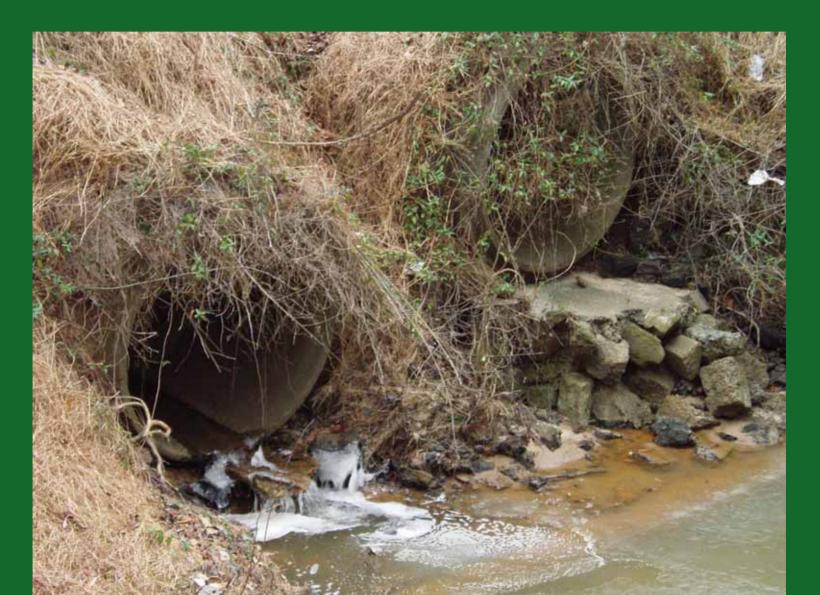
Other Illicit Discharges

Paint

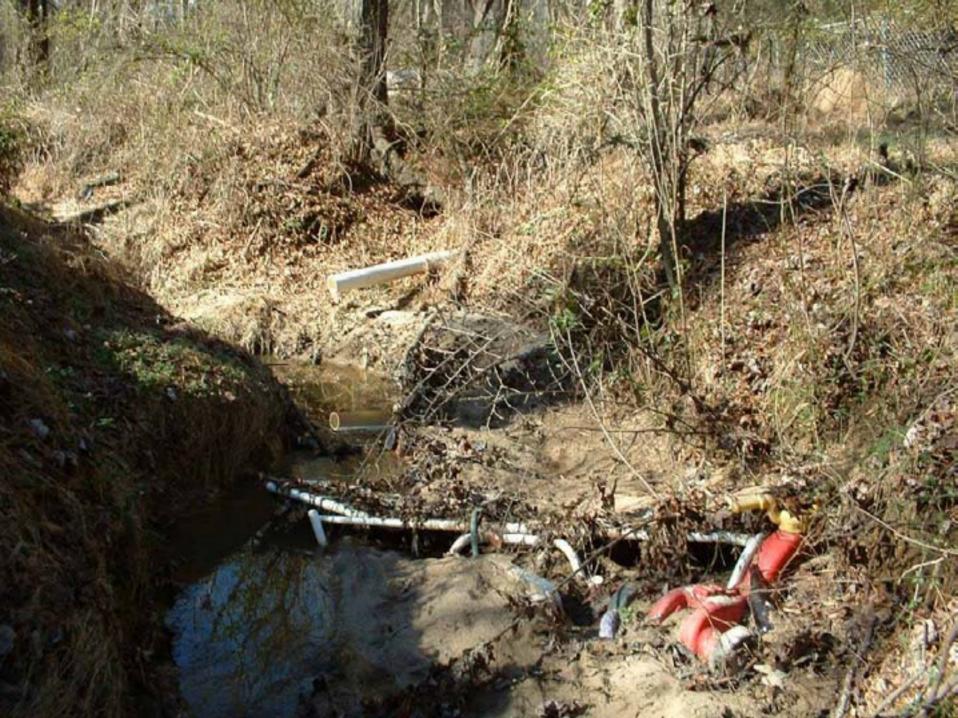
Trash Dumping

- Yard waste and household trash
- Oil filters and automotive trash
- Construction waste and commercial trash
