Upper Neuse River Basin Association

Re: Little Lick Creek Technical Memorandum #4—Priorities for
watershed restoration in Little Lick Creek

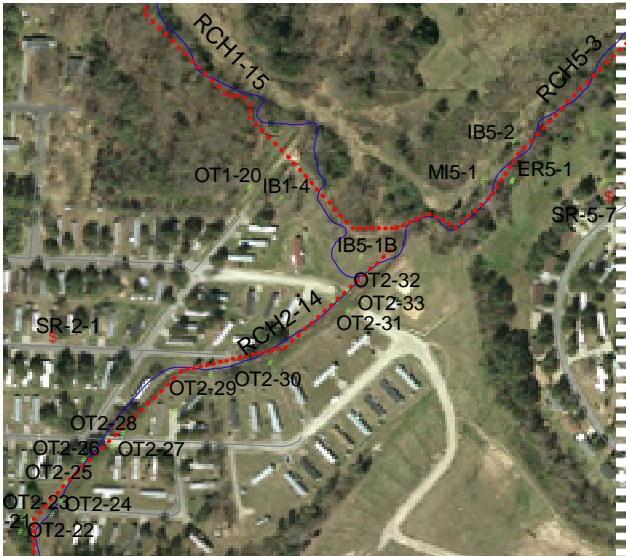
Reach 2-14, Impacted Buffer 2-10

IB 2-10 would add buffer to more than 1,000 feet of stream along Reach 2-14 in a mobile home park in subwatershed 2. The project is one of the most highly scoring buffer restoration opportunities and appears to meet NC EEP minimum length criteria on a low-order stream.

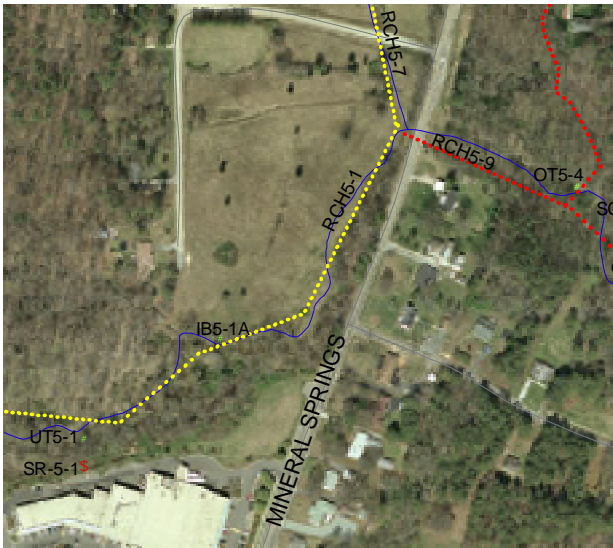
Reach 5-1, Impacted Buffer 5-1A

This project can be combined with Reach 5-7 to present up to 1,350 feet of buffer restoration or enhancement. The project is on private land north of the Mineral Springs-NC 98 intersection, behind Mineral Springs Shopping Center. The project is located on project Reach 5-1 in subwatershed #5. Buffer restoration and enhancement are needed along the left bank of the main stem of Little Lick Creek. Buffer restoration and enhancement are also needed along Reach 5-7, a tributary to Little Lick Creek that enters before the creek crosses Mineral Springs Road and continues to the northeast (Reach 5-9).

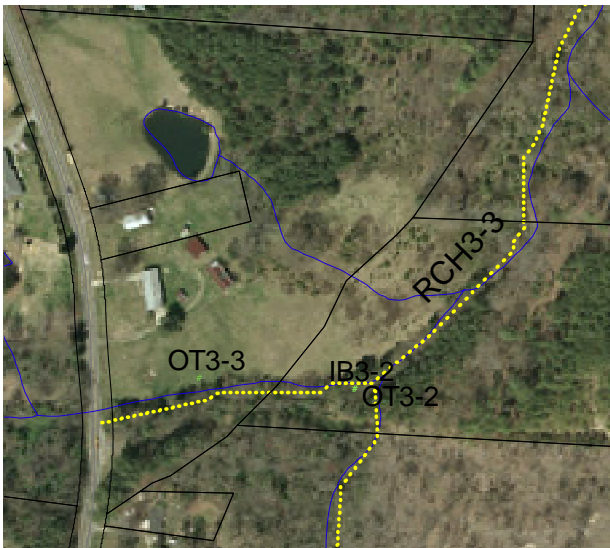
Reach 3-3, Impacted Buffer 3-2

This project presents an opportunity to enhance and restore buffer along Reach 3-3 and a first-order tributary along 3-3 (with a farm pond). The total distance of the buffer restoration/enhancement could be as much as 1,100 feet, not including a buffer on the farm pond. The project scores only 7 out of 17 total prioritization points; however, it meets EEP minimum distance criteria on a low-order stream.

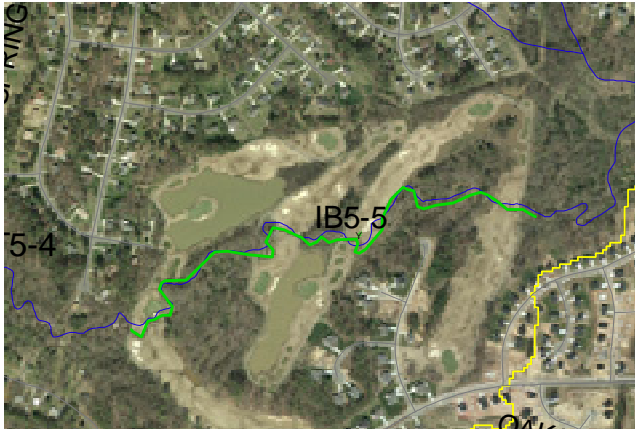
Reach 5-10B, Impacted Buffer 5-5

This potential project is located along project reach 5-10B, located in subwatershed 5 on the main stem of Little Lick Creek. The opportunity exists for approximately 1400 linear feet of potential buffer enhancement. The potential project is located along fairway of hole #16.

Buffer enhancement is needed on a section of stream that crosses the fairway in front of the tee box. Here, using low shrubs or raising the tee box would be necessary. There is also need for restoring the left bank buffer located adjacent to the fairway. Here, larger trees could be used, but a 50-foot buffer would require adaptations to the fairway. Other constraints include unstable banks and two stormwater outfalls from an adjacent neighborhood (these outfalls could be addressed as part of the project).

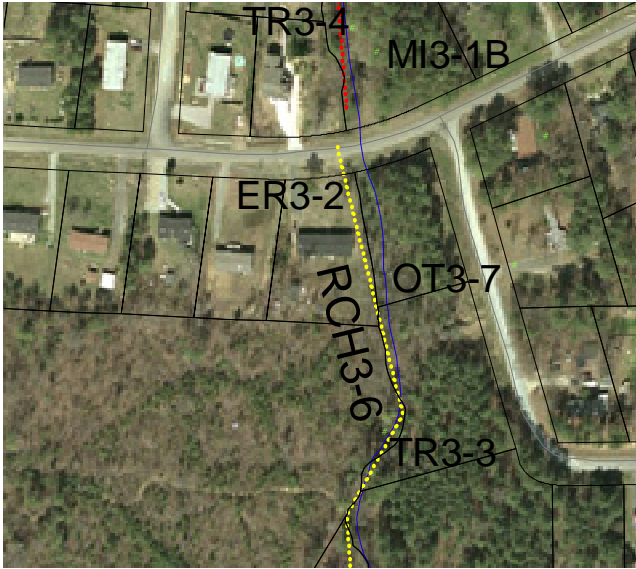
Reach 3-6, Erosion Impact 3-2

ER 3-2 is a portion of a first (possibly second)-order stream experiencing very severe, active downcutting and widening adjacent to homeowner property. There is a need for bank and channel stabilization. The project is located directly upstream of the crossing at Pennock Rd. This active erosion is contributing to the poor condition of the downstream reach (Reach 3-7). Four landowners would be involved.

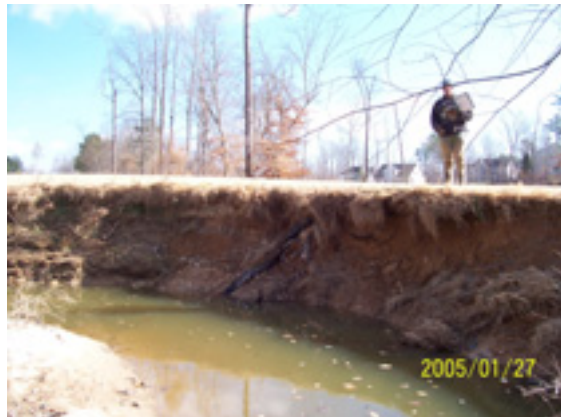
Potential Project ER 5-8 on Little Lick Creek

Each of the erosion impacts is severe and active (see the photo of ER 5-8).

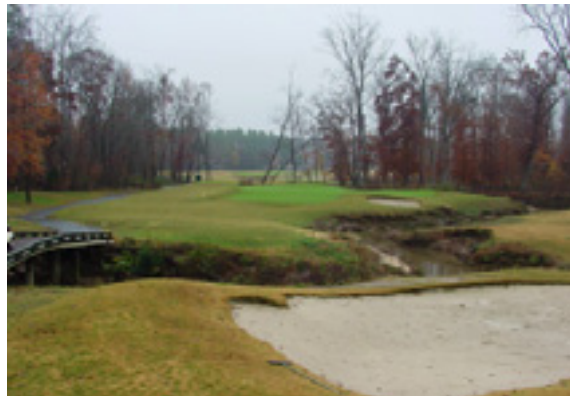
Potential Project IB 5-3 on Little Lick Creek

The impacted buffers are areas of the stream that are also desperately in need of bank stabilization, such as IB 5-3, the bank that is eroding into the 11th sandtrap and green (see the photo).

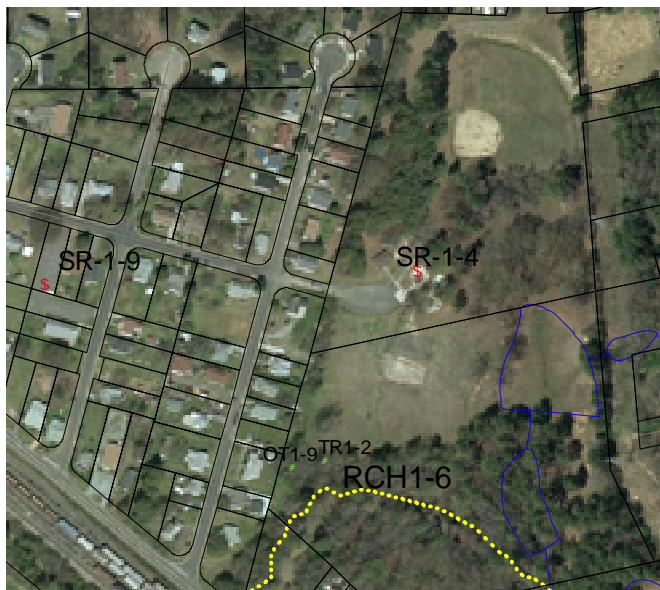
Stormwater Retrofit 1-4

SR 1-4 is an opportunity to treat up to 23 acres of urban residential, commercial, and industrial runoff with a constructed wetland and drainage system. The project could be located at the site of a historic pond in CR Woods Park, a city-owned property between Angier and East End Avenues in subwatershed 1. The project is one of the two highest scoring retrofit sites in Little Lick Creek.

At a minimum, the constructed wetland could treat 14 acres of residential runoff in an area of the park that appears to be lightly used. The project could use drainage to divert up to 9 additional acres of runoff from heavily urbanized areas nearby.

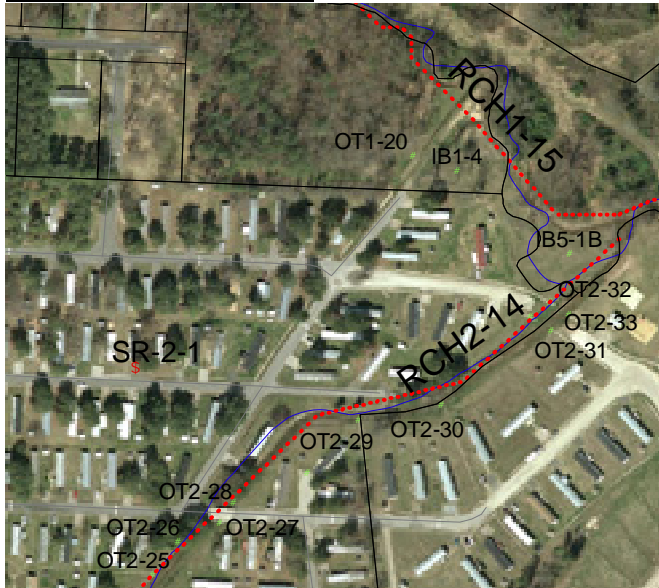
Stormwater Retrofit 2-1

SR 2-1 is a one of the highest-priority stormwater retrofit opportunities identified in Little Lick Creek. The project could treat 51 acres, all within one mobile home park, using stormwater wetland, bioretention, grass swales, and grass filter strips. The project could also be combined with high-priority buffer restoration opportunities along Reaches 1-15 and 2-14.

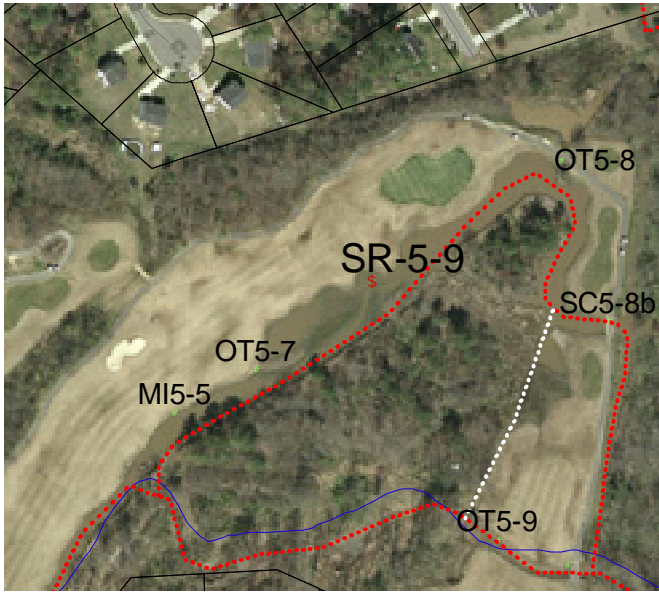
Stormwater Retrofit 5-9

SR 5-9 is another potential project on the Crossings Golf Club property. This project could treat 10 or more acres of runoff from a neighboring residential development to the north of hole 16. The project would use the water features along this golf hole to treat the runoff, which would require configuring the storm drainage system.

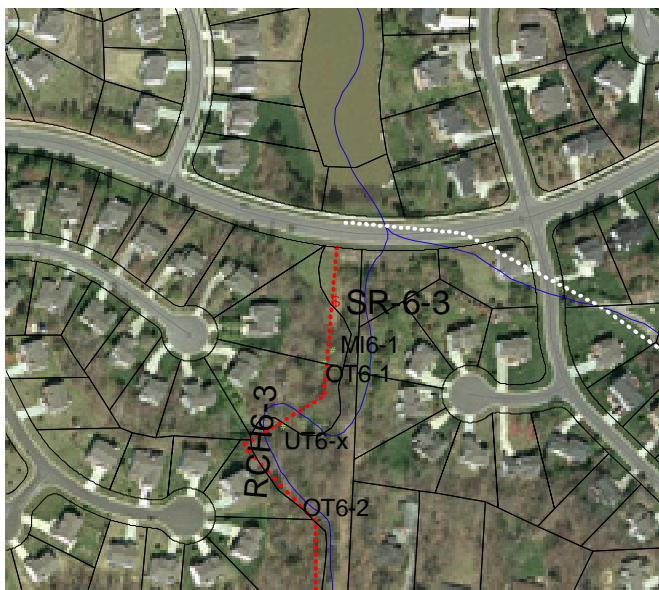
Stormwater Retrofit 6-3

SR 6-3 could drain up to 230 acres along project stream Reach 6-3. The project could occur mainly on homeowner association-owned property immediately to the south of Nichols Farm Rd. A forebay could be added at the road crossing to provide water quality treatment for the upstream area.
